STORM REPORT FROM WEEKEND OF JAN 14 TO 17 MLK WEEKEND

VINCE MURPHY - UPDATE ON FLOODING

MORGAN SAYLE - UPDATE ON EROSION AND EROSION MONITORING
PROJECT

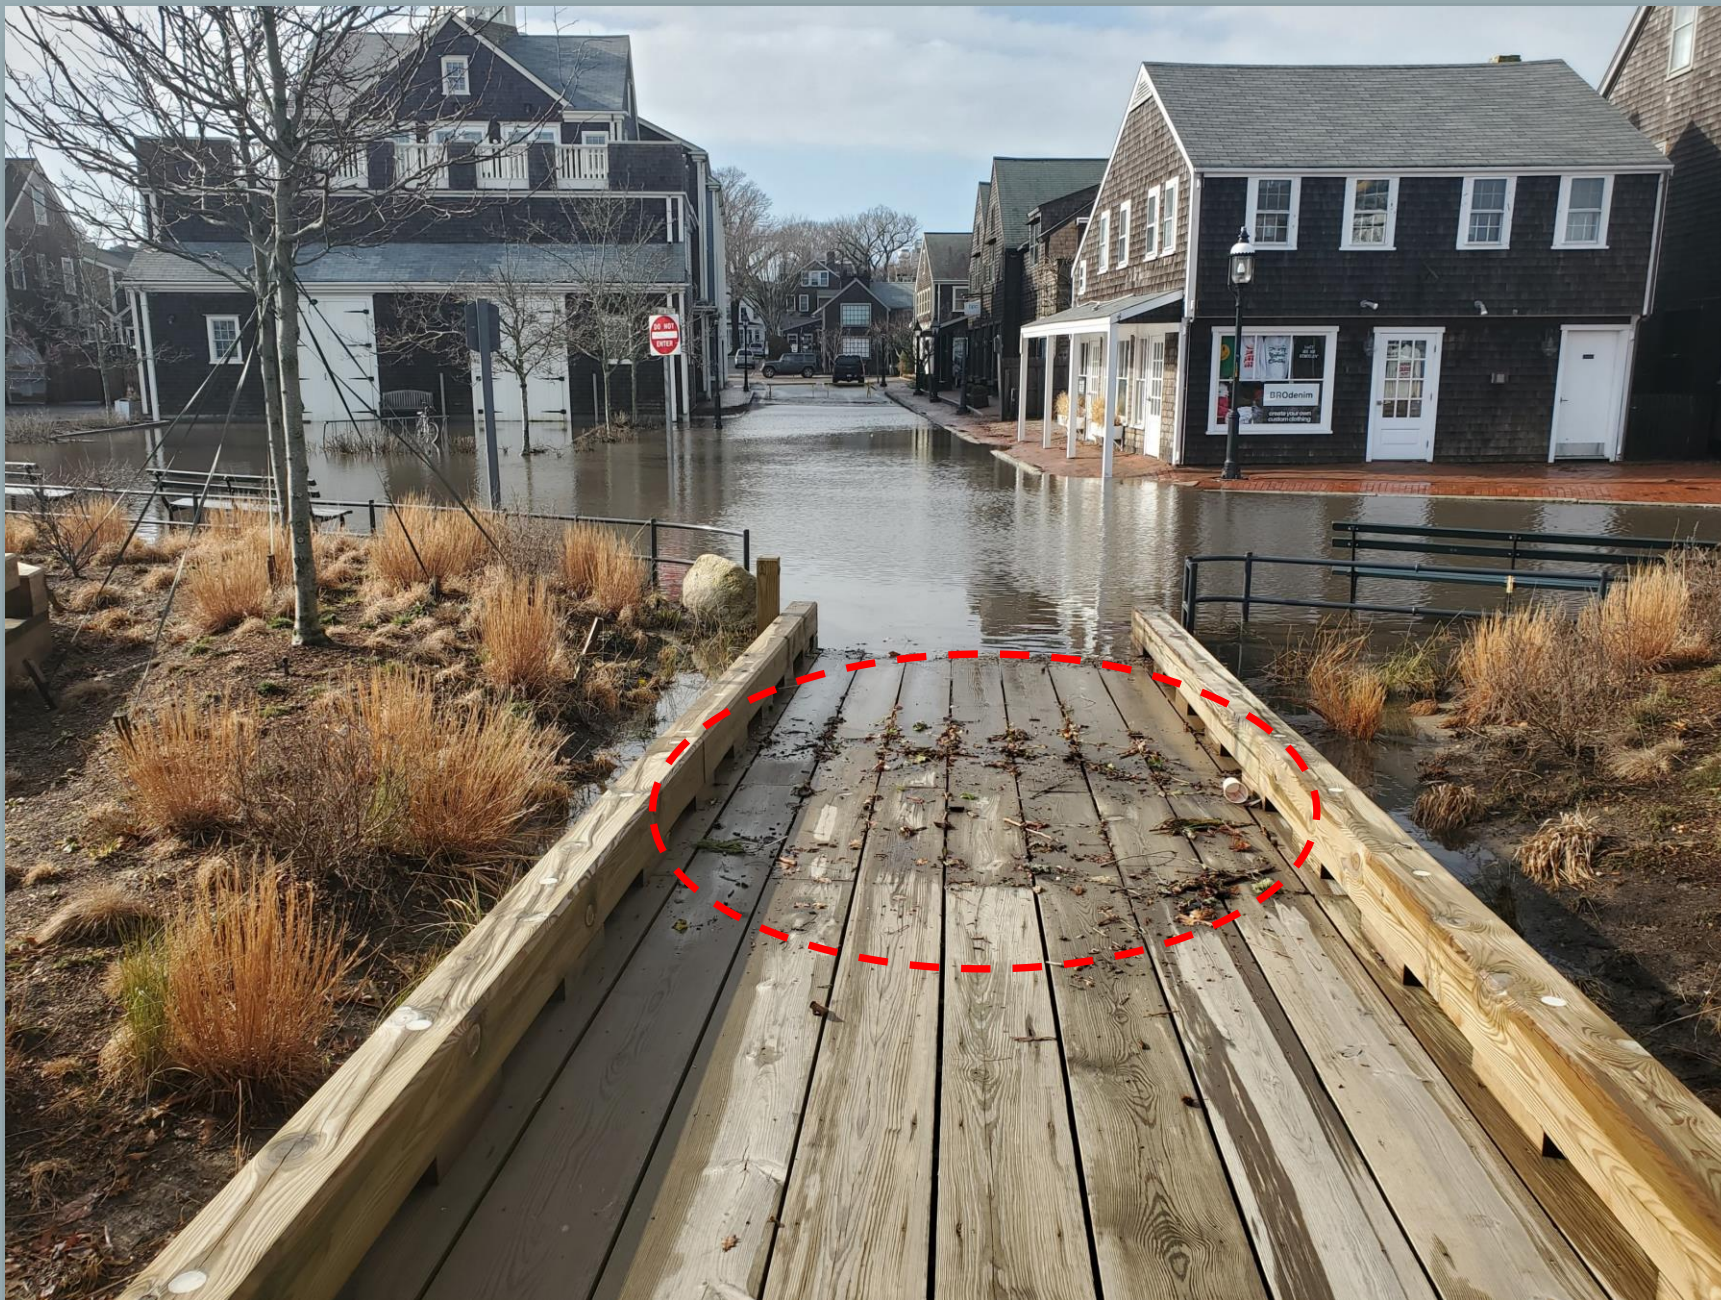
NOAA records 1.01 inches of precipitation at Nantucket Memorial Airport on Jan 17

High tide was at 11.40am on Jan 17, and this is the time of these pictures

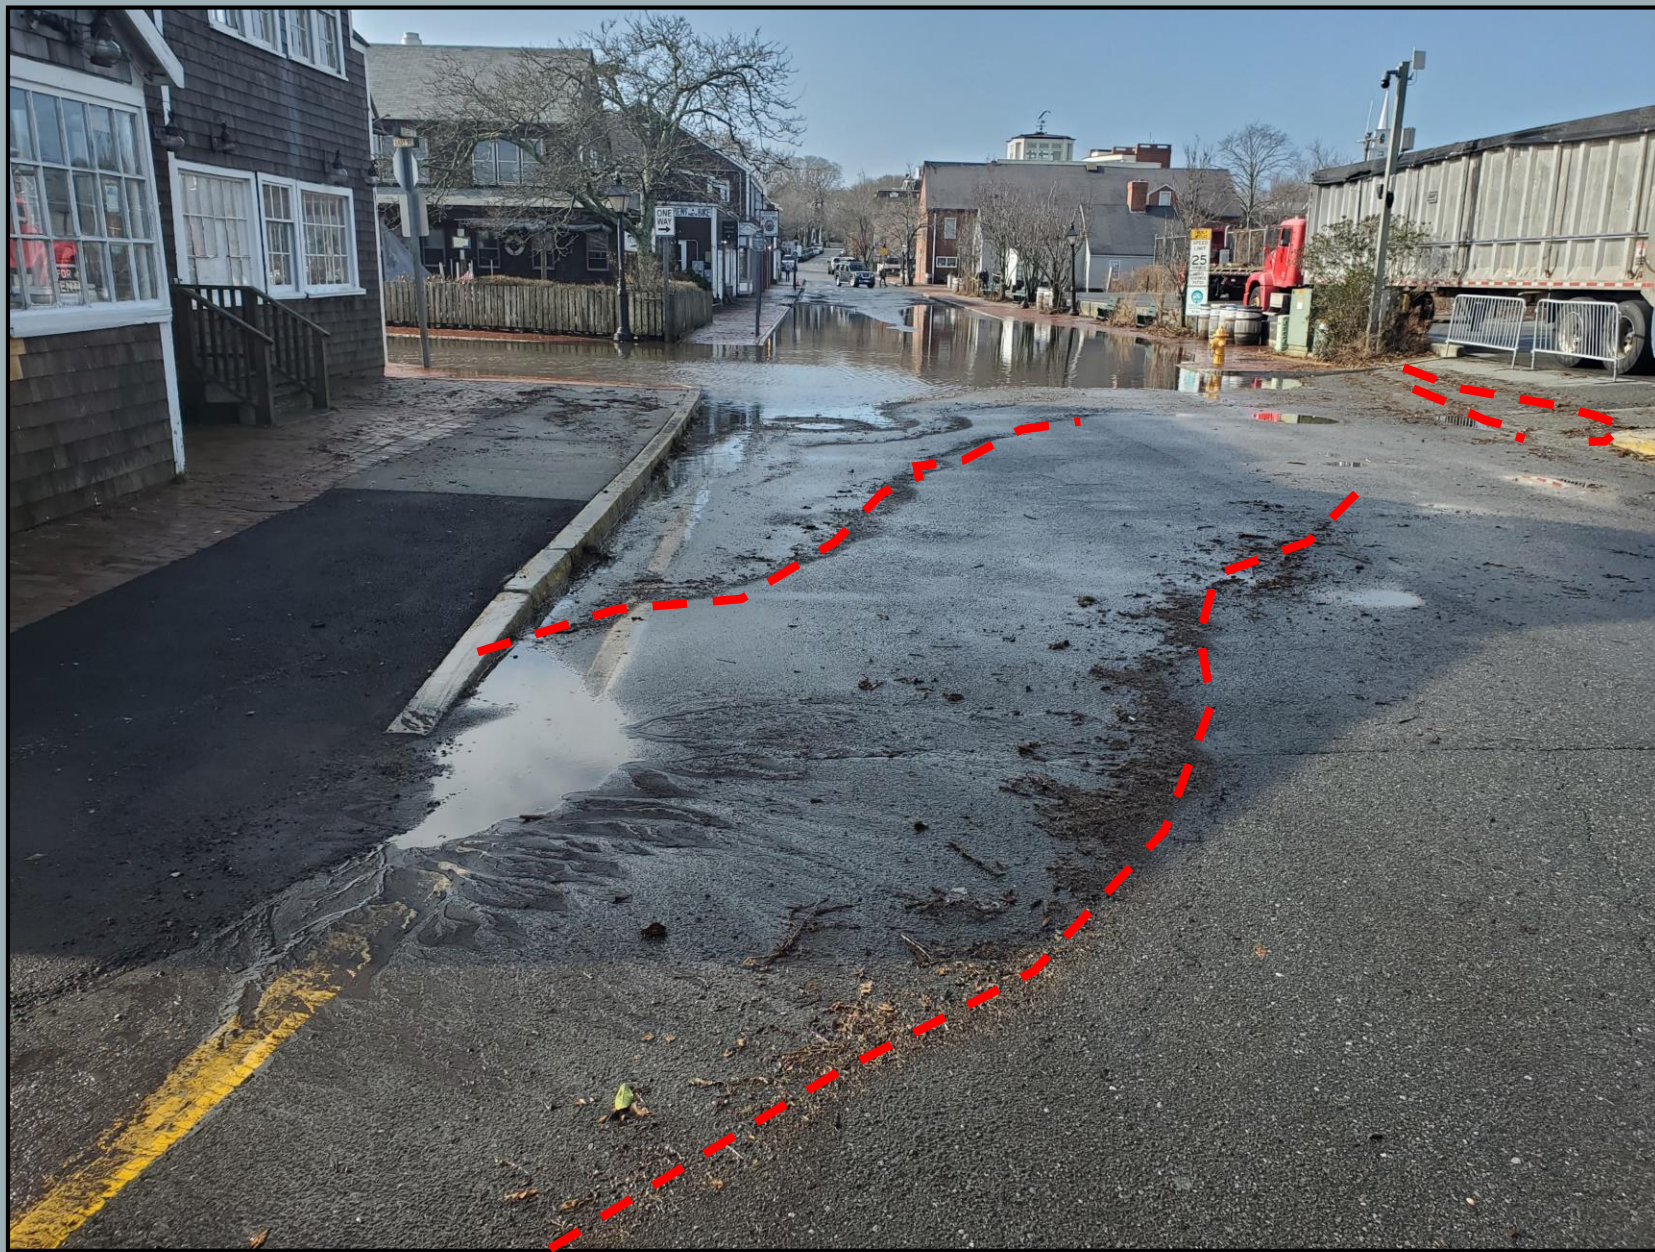
At least two tidelines. Looks like water levels were higher during the peak of the storm around 9am

Looks like it was mostly surface water from the storm and not salt water from the harbor.

At high tide, flow through the duckbills was observed, indicating enough water pressure to release flooding to the harbor through storm drains.

Did not measure salinity of water on street to confirm.

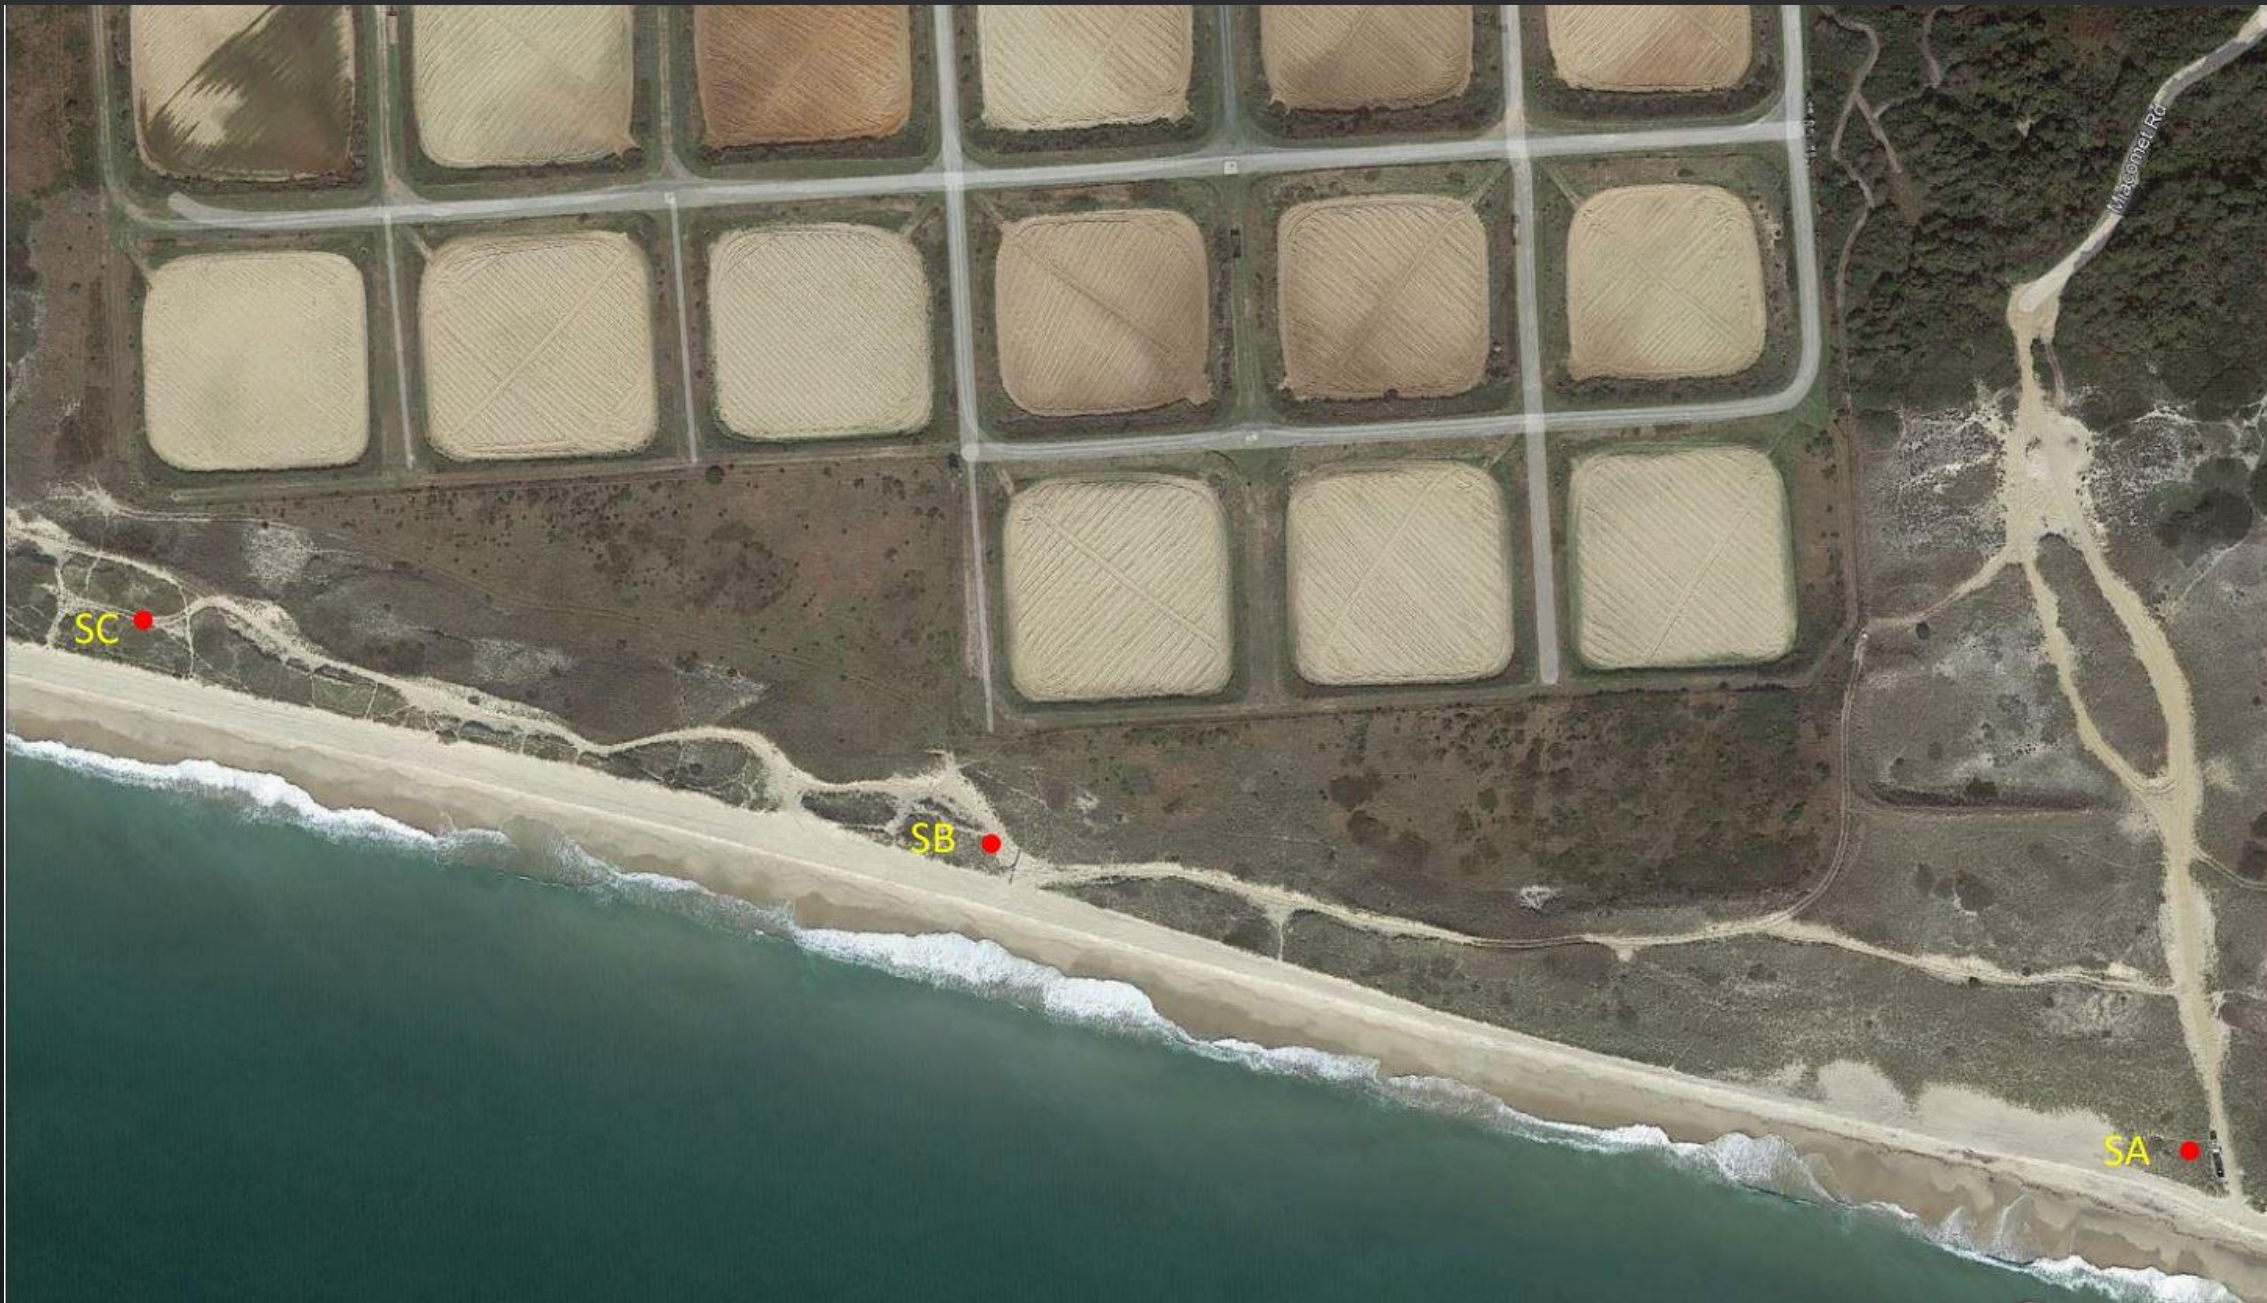
Fig. 4 – Overview of sewer treatment facility coastline with approximate locations of each monitoring station.

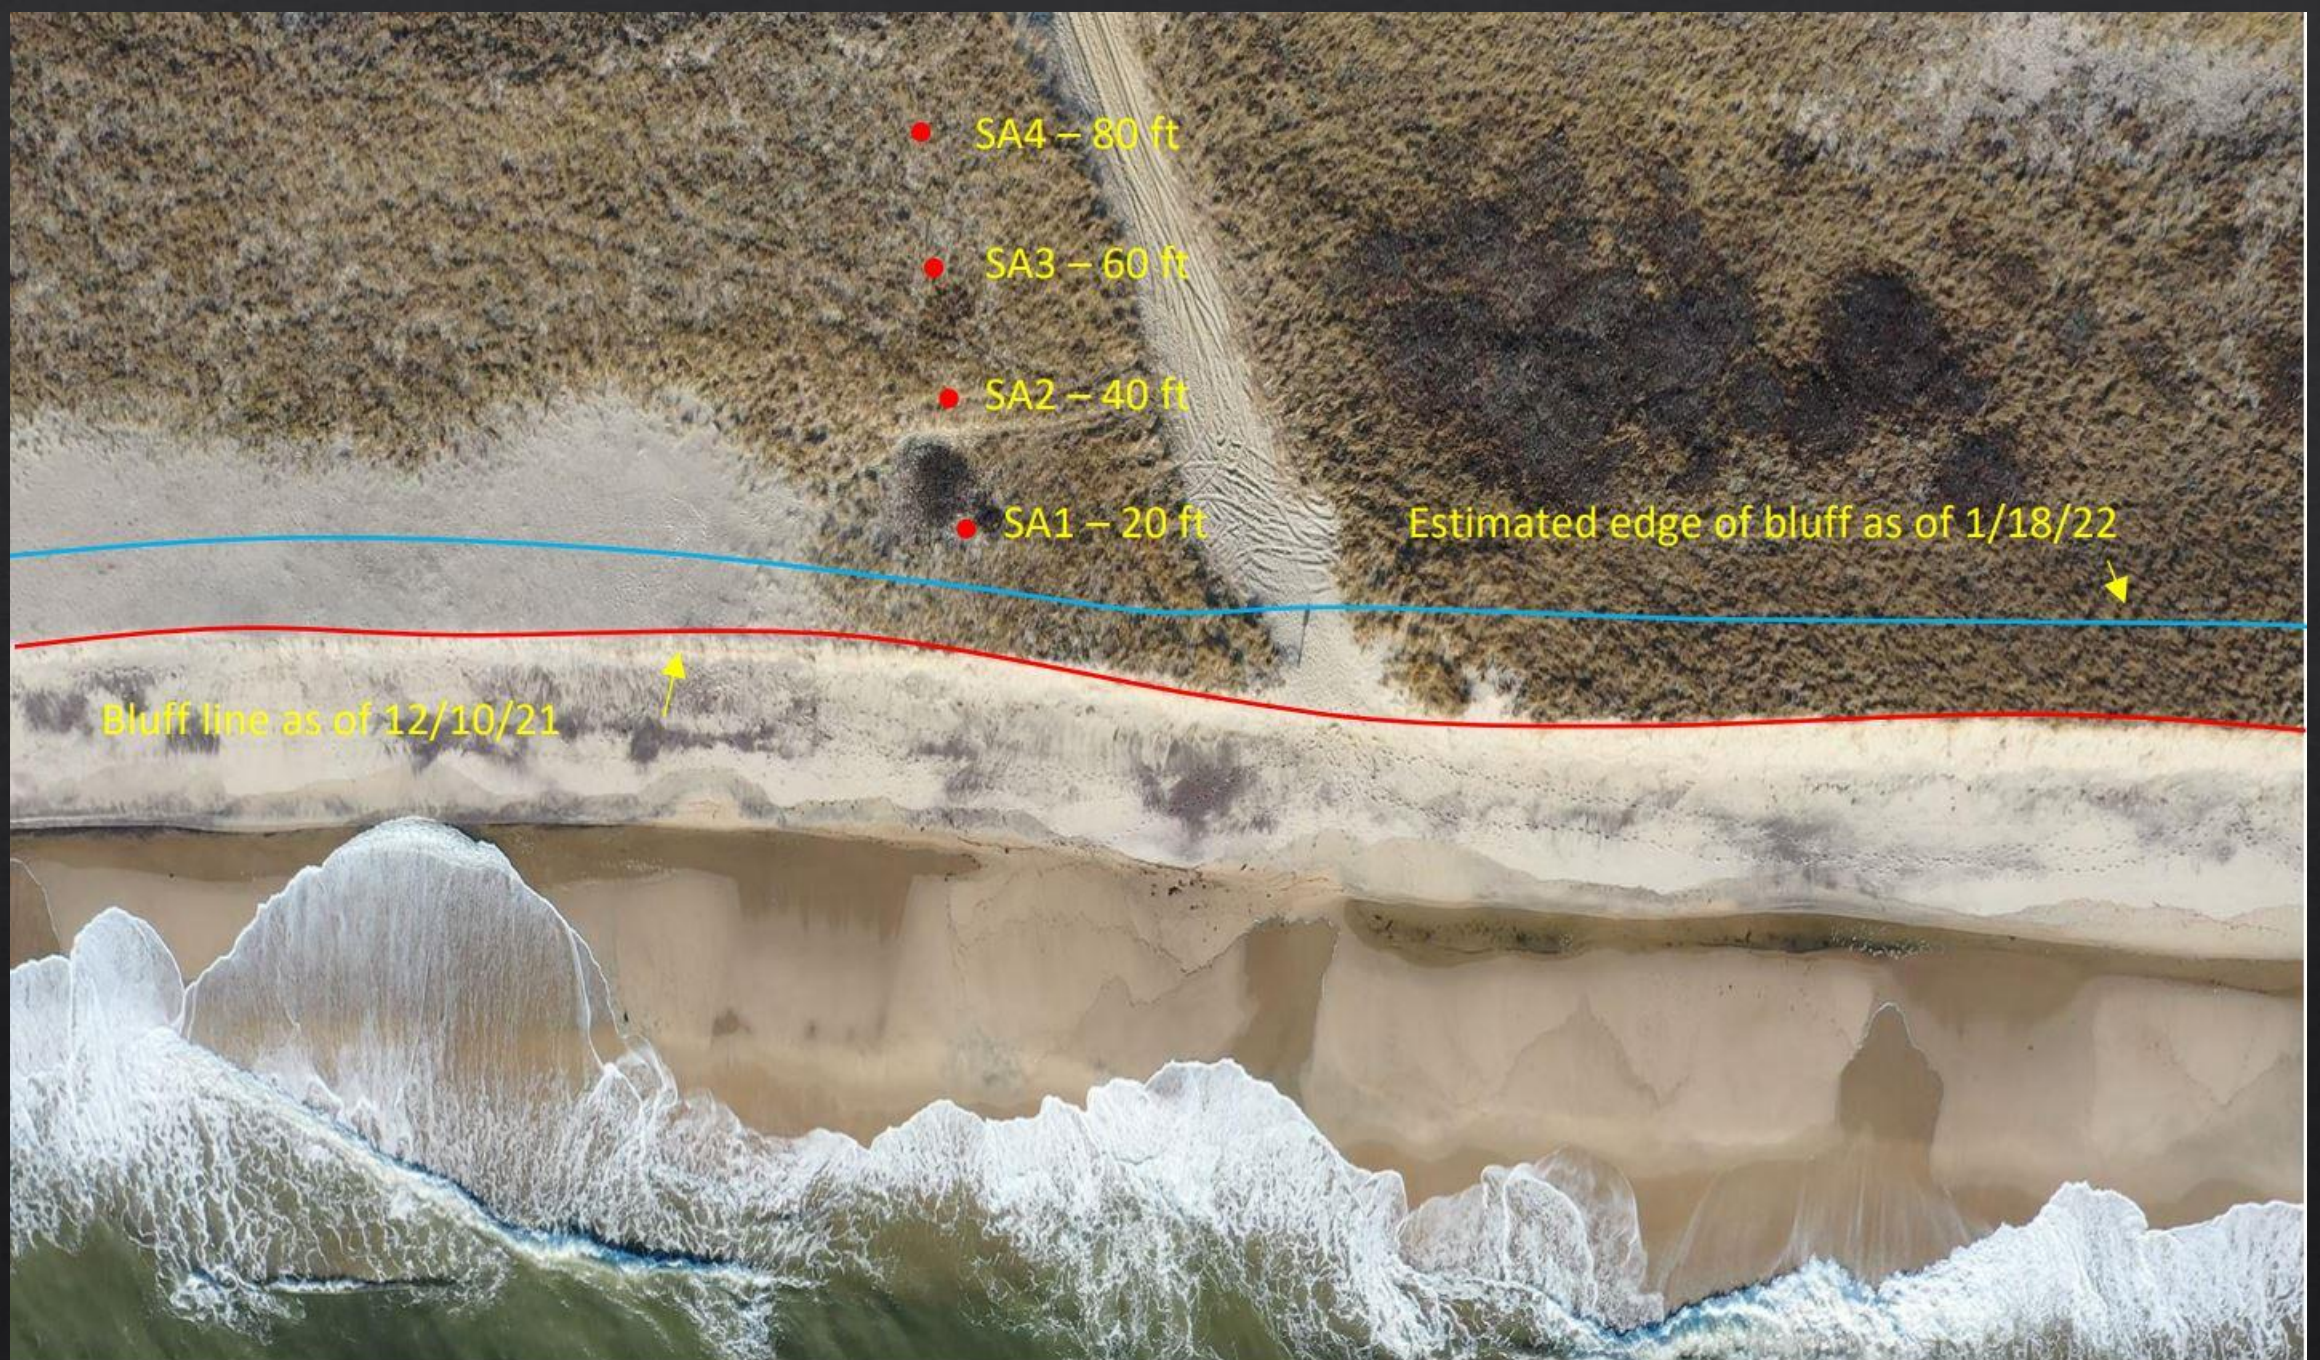
Fig. 1 – Station SA1, SA2, SA3, SA4.

This area of the south shore has been observed to be one of the more rapidly eroding areas of the island, with impacts to the shoreline being seen as a result of a wide range of weather events.

Station SA consists of 4 posts spaced 20ft apart – extra posts added for redundancy, in case one was lost or vandalized, etc.

No change throughout December into January, then 10ft lost – presumably over the course of the weekend

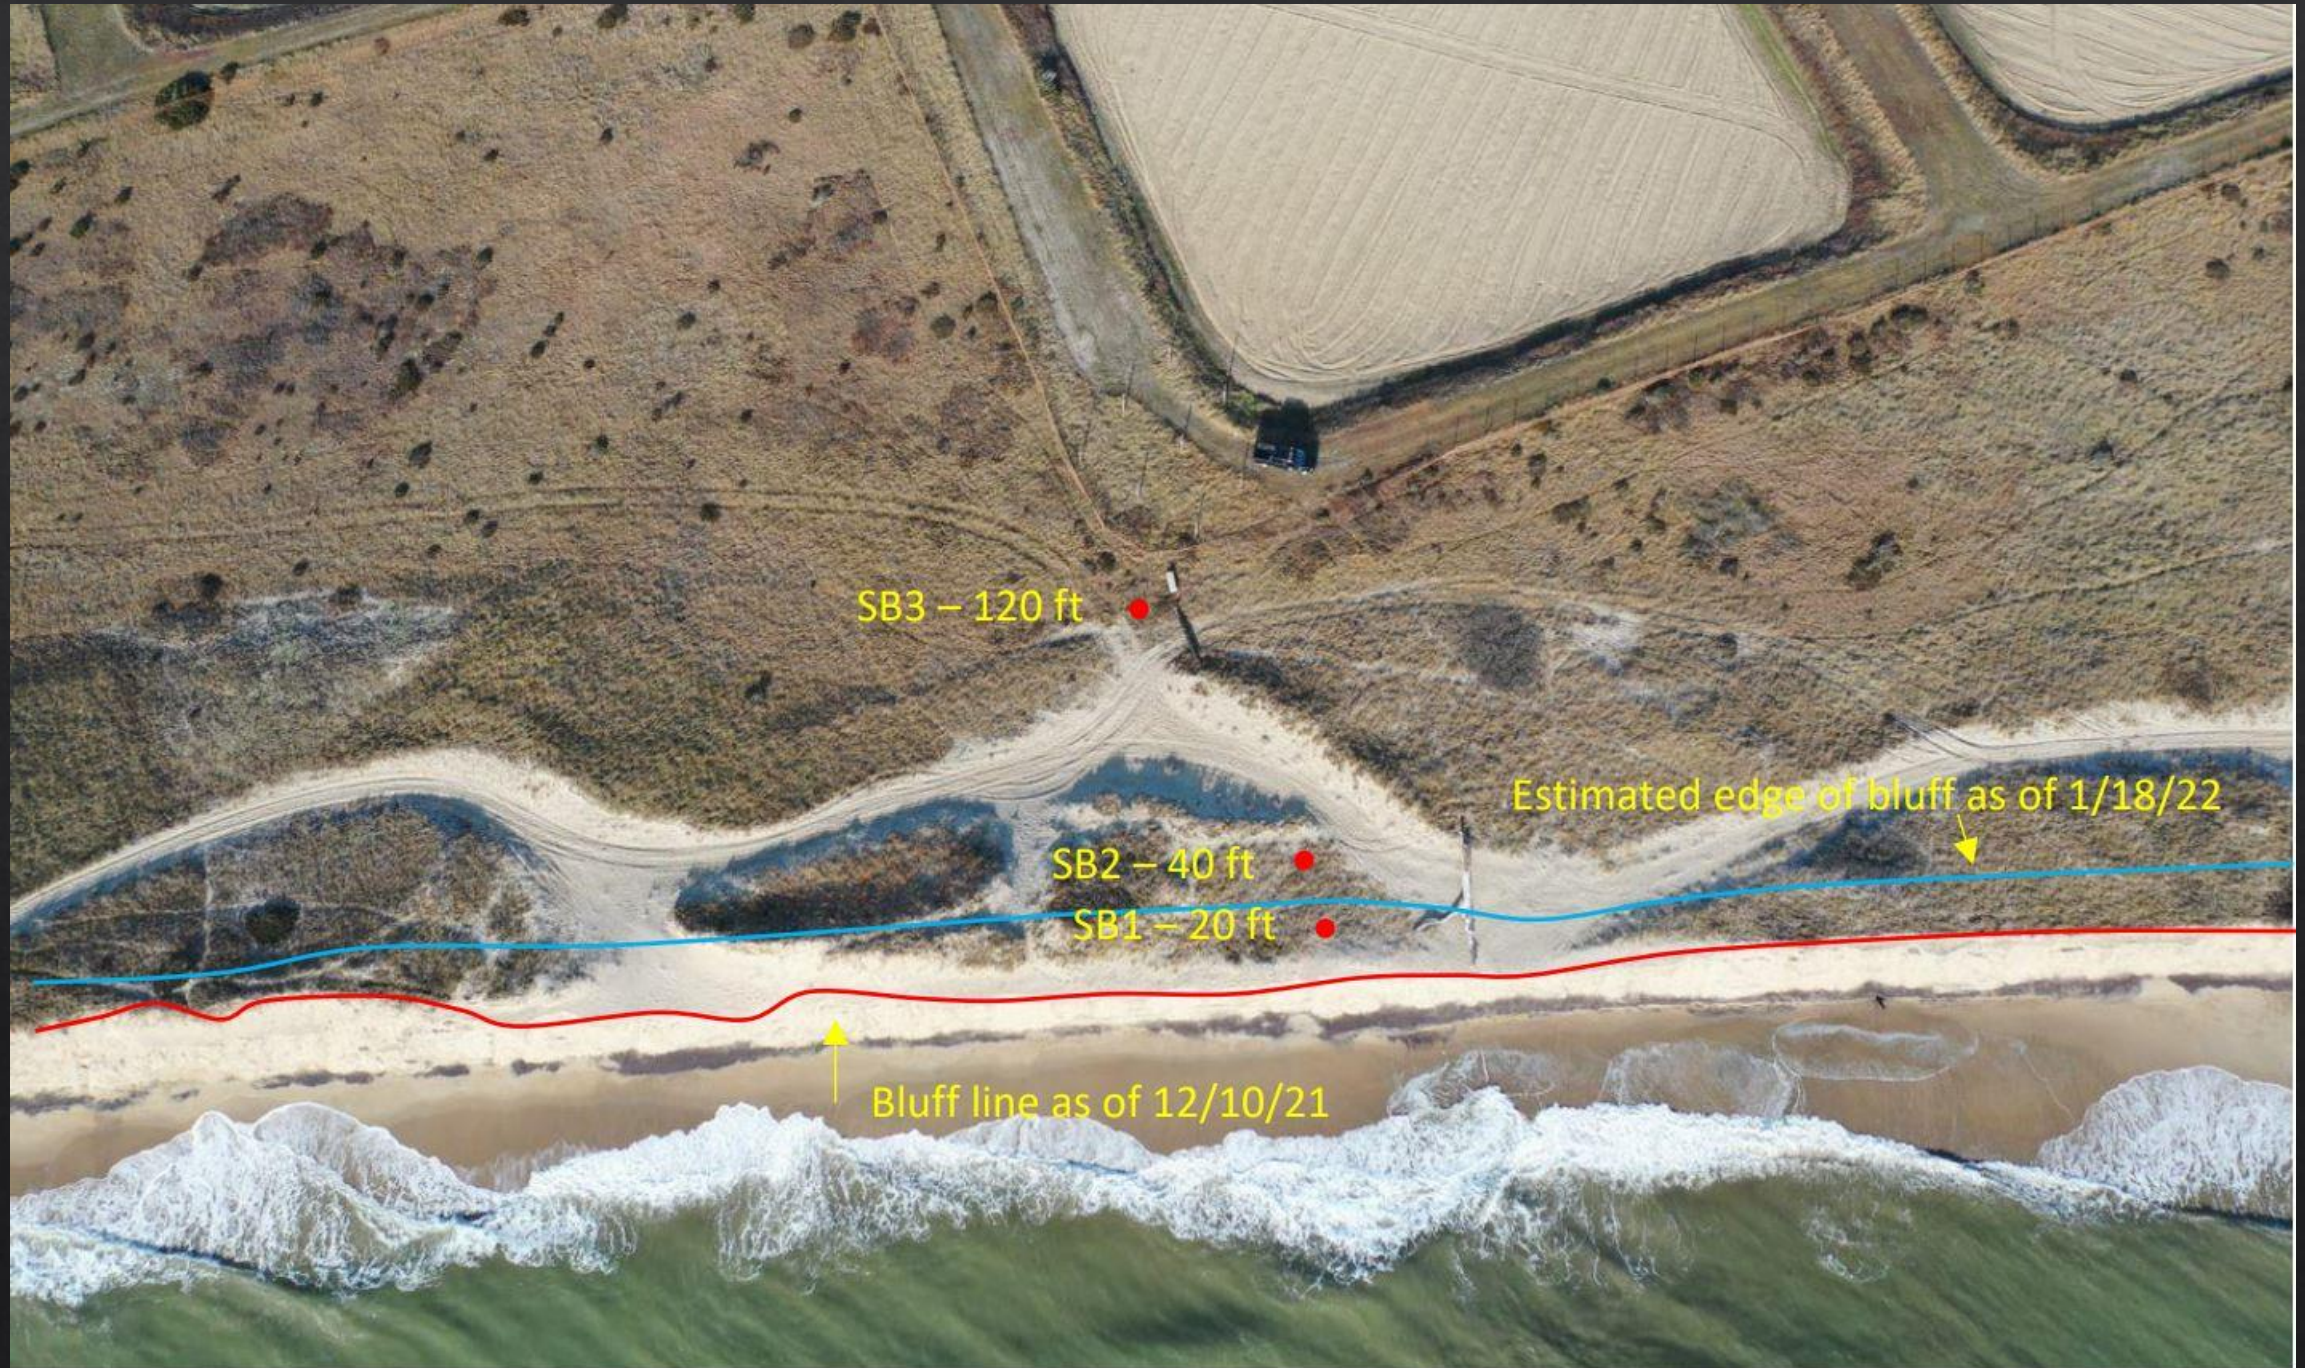
Fig. 2 – Station SB1, SB2, SB3. SB1 was lost to erosion.

Station SB consists of 3 posts spaced 20ft and 80ft apart to avoid vandalism or destruction from road – extra posts added for redundancy, in case one was lost or vandalized, etc.

At the time of installation the distance from the coastal bank to the fence-line surrounding the treatment facility was 135 feet. This has been reduced to 113 feet following these episodes of storms and wind throughout January.

Word is that SB2 has also been lost since last measurement.

Some change early Jan. after windy weather earlier in the month, then 18ft lost – presumably over the course of the weekend. Cumulative total of 22ft lost so far in January.

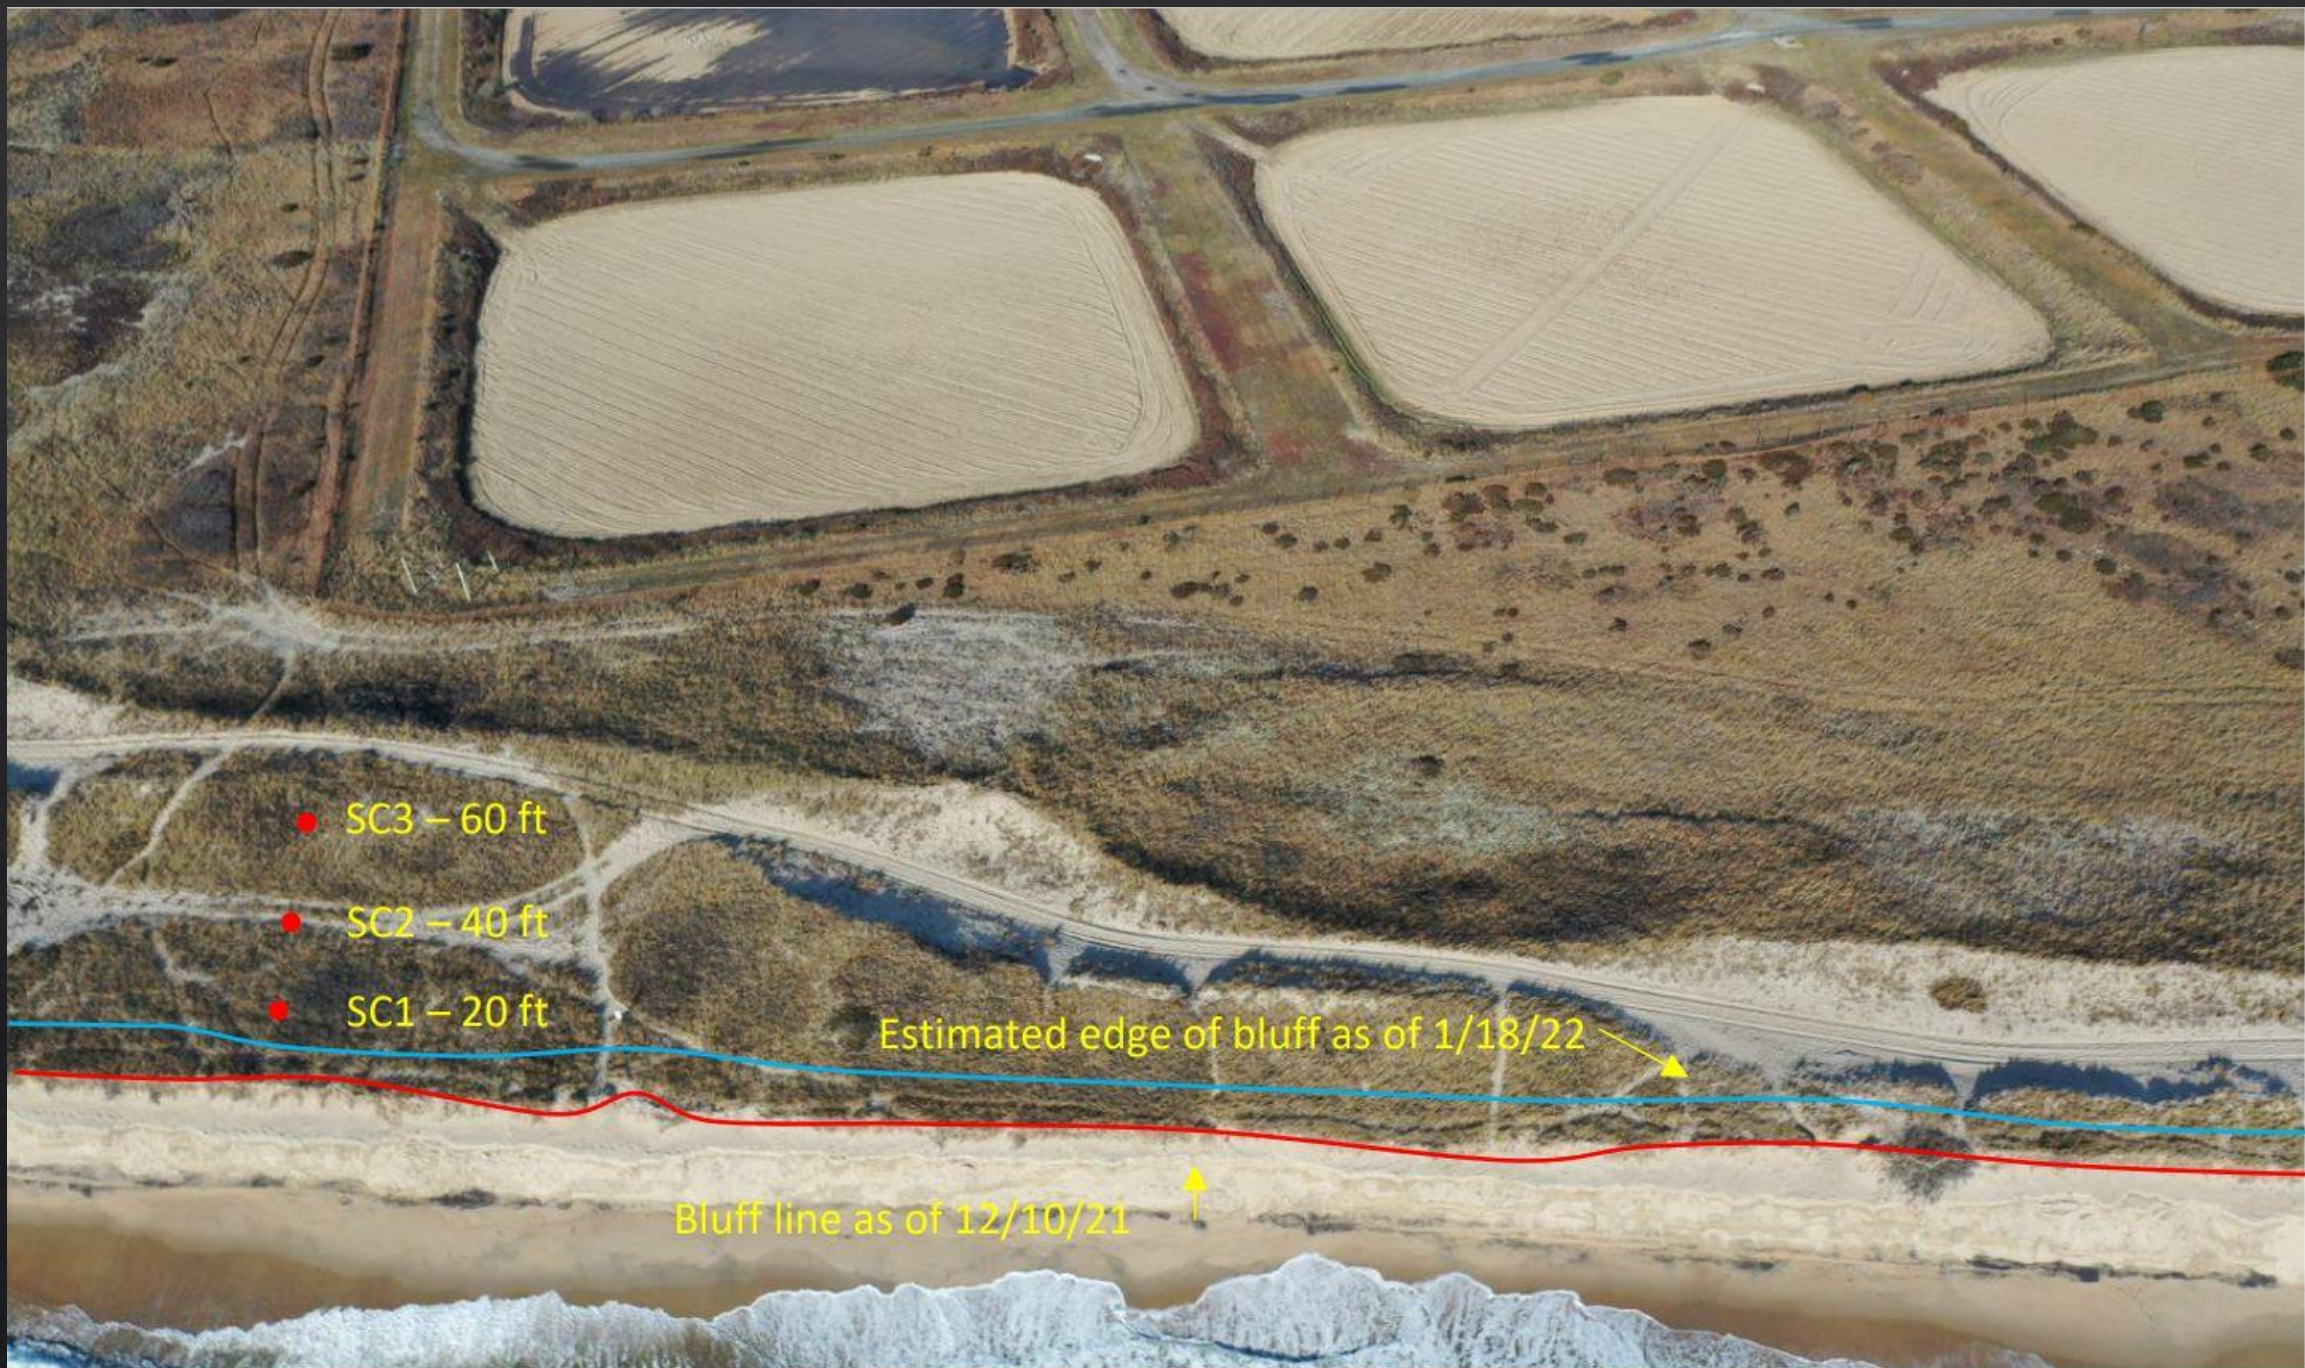
Fig. 3 – Station SC1, SC2, SC3.

Station SC consists of 3 posts spaced 20ft apart – extra posts added for redundancy, in case one was lost or vandalized, etc.

No change throughout December into January, then 10ft lost – presumably over the course of the weekend
